## **ARCHITECTURAL ANALYSIS OF THE RECONSTRUCTED BUILDINGS ENTRANCE UNITS OF KYIV HISTORIC CENTRE**

***Abstract:** positive and negative issues in modern entrance groups in Kiev of the late 19th and early 20th century were considered. Four main types of entrance groups and their most typical elements were identified. Search of the possible ways to preserve the integrity of heritage buildings.*

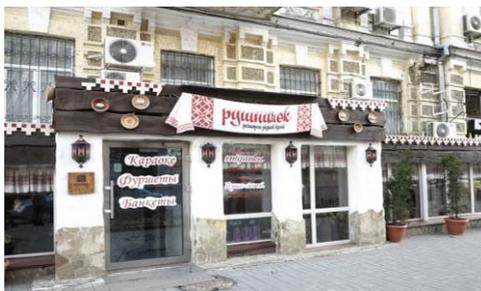
*Fig.1. Entrance units of the “Rushnichok” restaurant.*

Entrance units of Ukrainian cuisine restaurant “Rushnychok” on the Pushkin street, 25A (Fig.1) depart from the plane of the facade walls by means of enclosure and a shallow vestibule. Successfully used elements of Ukrainian embroidery, ornaments, pottery, together with the selected materials in the decoration, complement well to the integrity of the design decision of an institution, but only if taken separately from the facade. This is a positive example of color solution, but also a negative example of inconsistent separability of the first floor facades general structure. Entrance units and institutions shop windows are out of scale relatively to the proportional and metro-rhythmic facade construction.

2. – Volumetric entrance units (external tambour) retreating from the plane of the wall usually by 1-2 meters of closed internal space (Fig.1, 6, 7);

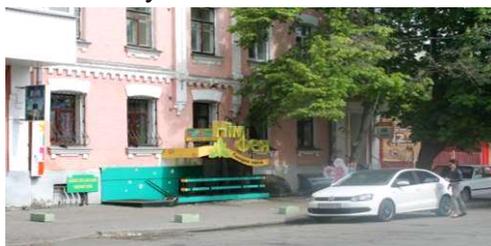
*Fig.2. Entrance units of the “Nimpheia” cafe.*

The entrance units of “Nimpheia” cafe on the Spasska street 11 (Fig.2) depart from the plane of the facade and also include stairs into the basement. This is an example of quite an unfortunate design decision, because it does not meet the facade by color, shape or scale, not even by style. The advertising sign is posted poorly; it shuts the half of the window and spoils the overall composition of the facade. The size and nature of letters does not match the scale of the facade.

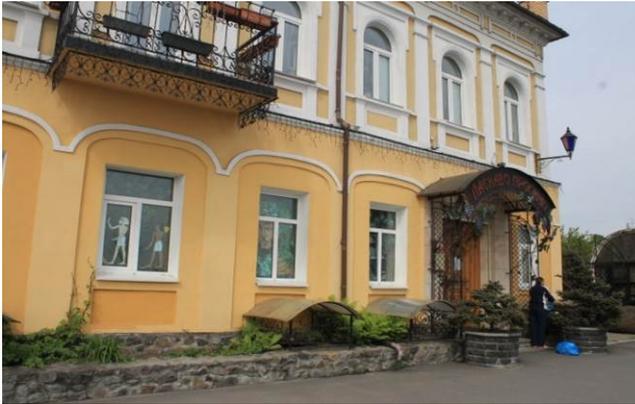
*Fig.3. Entrance units of “Masandra” shop.*

Entrance units of “Massandra” shop on Naberezhno-Khreschatytska street 19/21 (Fig.3) includes a canopy with forged decorative consoles – an example of successful usage of forged elements which repeat the decorative metal-plastic facade motif (in this case the decorative motif of balcony railings). The circular form symbolizing the sun and the arched shapes can be traced in the window, canopy and decoration of the facade decisions, which are decorated with a metric number of rounded, wavy elements above the windows. Forged canopies are the most common elements in Kyiv entrance units’ design.

3. – Entrance units with canopy (often with consoles) with partially opened space in front of the door (Fig.3) retreating from the plane of the wall mostly by 0,7-1,5 meters;

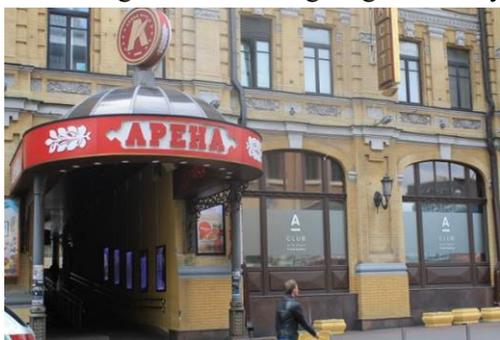
The entrance units’ decision on the Chervonoarmiiska/Baseina street 3/2 (Pic.4) follows the Kyiv characteristic iron canopies on columns. The molded ornaments that resonate with plaster facade decorations are used here. The dome form resembles a semicircle shop windows on the first floor. But the color of signs, its decor,

letters size, logo and shiny dome material do not meet the general concept of the building and look more like kitsch.

*Fig.4. Entrance units of the “Arena” club.*

4. – Entrance units carried out by the columns, with an open passage space beneath it (Fig.4, 9) retreating from the plane walls by 2-4 meters.

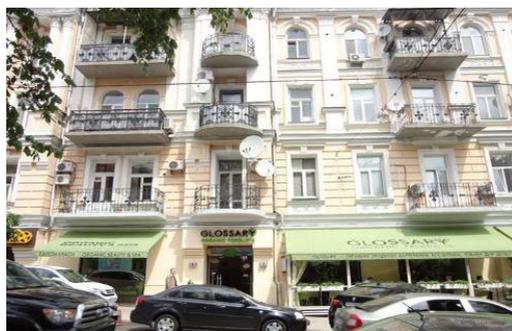
Entrance units of the beauty parlor at Volodymyrska street 40/2 (Fig.5) has no permanent building additions, modern materials and simple, light constructions “marquee” are used, they can be easily removed, but large shop windows violate the proportionate and metro-rhythmic structure of the facade. The font and the emblem of the institution, as well as the colors are successfully chosen. Light green along with the contrasting black color with white and beige colors of the building and contrasting forged balcony railings.

*Fig.5. Entrance units of the beauty parlor.*

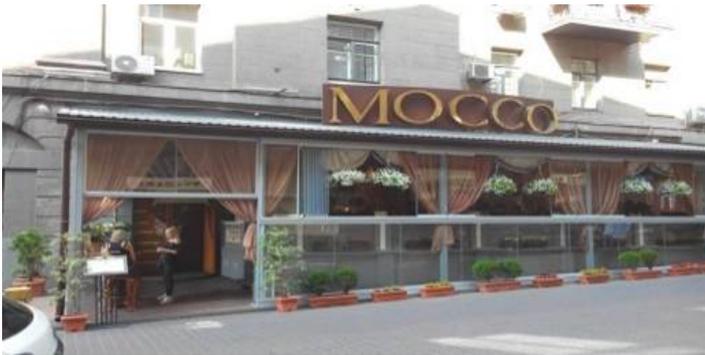
The restaurant on the Khreshchatyk street 15/4 has entrance units resolved in the form of rectangular vestibule slightly retreating from the plane of the wall. But its proportions, scale and division do not

correspond to the structural organization of the facade. Signs and font size are too large (Fig.6).

*Fig.6. Entrance units of the “Mocco” restaurant*

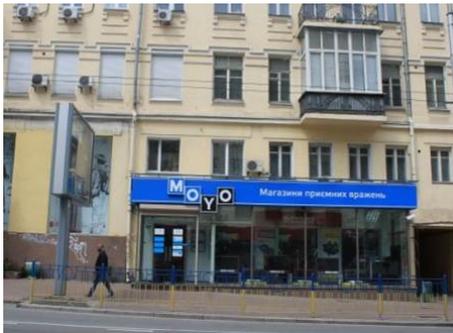
Entrance units in electronics store on Saksaganskogo street 16/43 (Fig.7) – do not meet either the scale or style of the building, the sign is of bright blue color not suiting the delicate pastel tones of the facade. The proportions and separability of the entrance units violate the proportional and metro-rhythmic organization of facade.

*Fig.7. Entrance units of the electronics shop.*

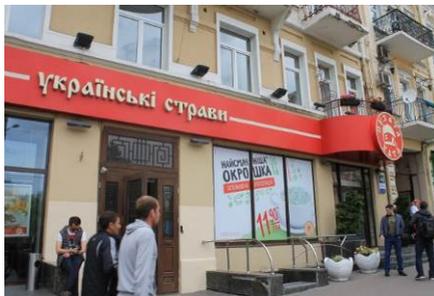
*Fig.8. Entrance units of the catering facilities.*

The main element of the entrance units of catering facility on the Chervonoarmiiska street 40 (Fig.8) is the canopy with the balcony on it, decorated according to the logo name. The windows of the first floor, advertising and the sign are out of scale to the elements of the facade building. The beige color of the logo repeats the color of the facade, but the bright red color is too contrasting, in the result the huge red sign crosses the facade and spoils the impression of the building.

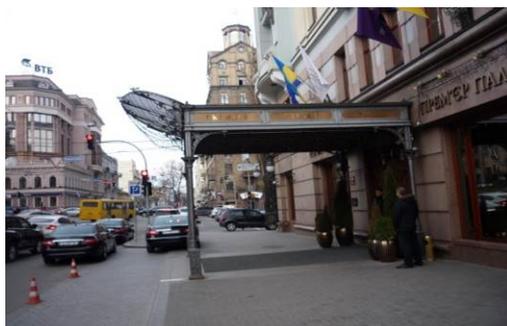
*Fig.9. Entrance units of "Premier palace" hotel.*

The entrance units of "Premier Palace" hotel, which are situated on the Pushkinska street (Fig.9), look pretty presentable. The main accent element here is a characteristic for old Kyiv canopy carried out on the entire width of the sidewalk with molten metal pillars and an opened passage space underneath it. Proportions, color,

architectural and artistic decisions are consistent with the composition of the facade and the environment.
