*State University “Kyiv Aviation Institute”, Ukraine***DAMAGE OF CARBON PLASTICS FROM LOW-VELOCITY IMPACT AND THEIR RELAXATION**

*The damage assessment of carbon plastics with different filler structures based on the same epoxy matrix HexPly M 21 from low-velocity impact was carried out. The purpose of the research was to determine the difference between the depths of dents and the diameters of damage of carbon plastics that had two different fillers, namely bidirectional fabric and unidirectional carbon tape. Low-velocity impact tests were carried out with the same energy of 6.7 J per 1 mm of sample thickness. Immediately after the impact, damage parameters such as the depth of the dent and the maximum size (diameter) were measured, with the latter being determined from both the front and back sides. The depth of the dent was measured immediately after impact and after 7 days to determine the degree of damage relaxation, which reached 17%. The results of the studies are presented in the form of histograms of dent depths and damage diameters on both sides of the samples. It was found that the damage diameters for carbon plastics of both performances on the back side are significan

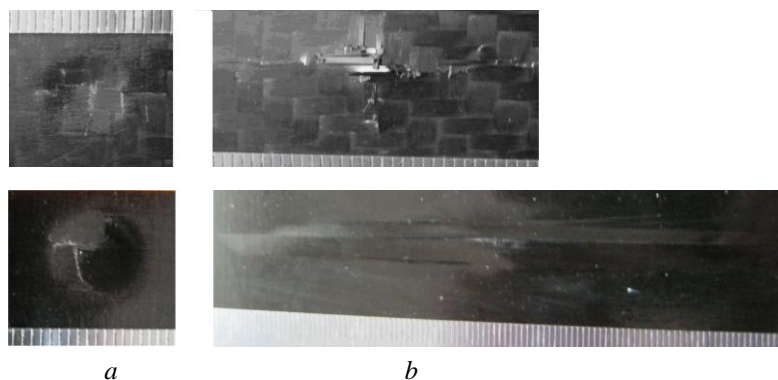
Fig. 1. View of damage on the front (*a*) and back (*b*) sides of the carbon fiber composites.

**Introduction.** The use of the modern polymer composite materials (PCM) has allowed replacing traditional metals in advanced military aircraft designs. The weight of PCM elements reaches 50% or more in the designs of modern passenger aircraft Boeing 787 and Airbus 350, which provides a significant increase in their economic efficiency. In the advanced designs of these passenger aircraft, carbon plastics are mainly used, these are PCM, which allow the manufacture of structures up to 40% lighter in weight compared to similar metal ones and are significantly more technological than metal ones. Carbon plastics are the most common in aircraft designs due to their significant rigidity and low weight, but, at the same time, they are sensitive to shock actions that are possible during their operation. Damage, which is a barely visible consequence of low-speed impacts on the front side of the sample (Fig. 1,*a*), is significant on the back side (Fig. 1,*b*) [1].

In the standard [2] dedicated to the study of PCM damage during low-velocity impact with low energy, the concept of - Berely Visible Impact Damage (BVID). The presence of such damage on the front surface of the carbon fiber can lead to significant damage on its back side (see Fig. 1).

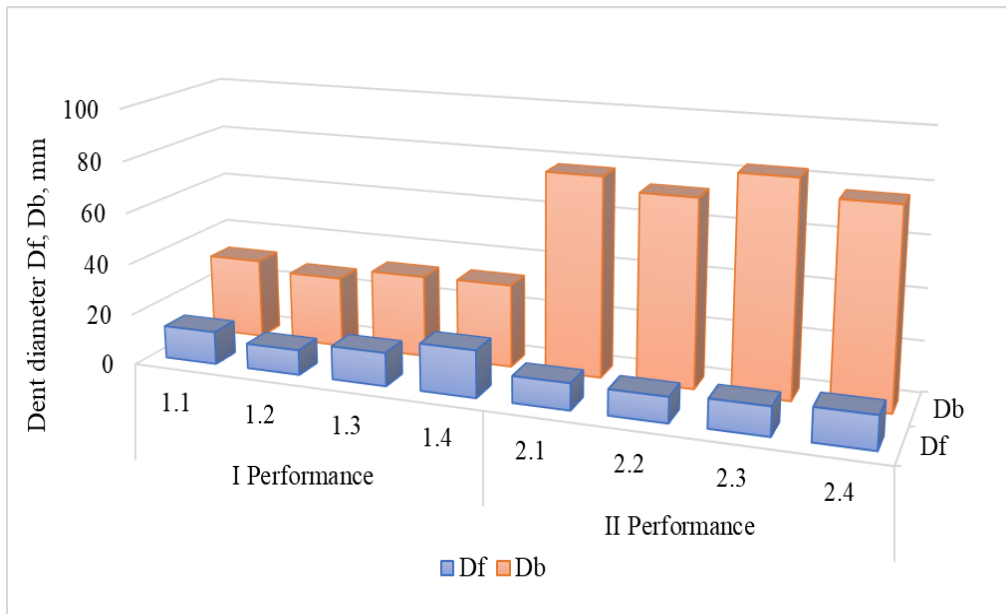
Fig. 2. Histograms of front  $D_f$  and back  $D_b$  dent diameters of samples of both performances.

**Analysis of results and discussion.** After impact, each sample was fixed in a special fixture and within 15 minutes after testing, measurements of the depth  $d_0$  of damage (dent) of the sample were made using a specially designed depth gauge, which included a watch-type indicator with a measurement accuracy of up to 0.001 mm. Next, the damage to the sample after impact was visually recorded, the type of damage was determined and the maximum linear size (diameter according to the standard) of the damage on the front side  $D_f$  and on the back side  $D_b$  was measured using a digital caliper. In order to avoid subjective influence on the results of determining the depths of dents and diameters of damage, measurements of all samples in this study were made by one specialist. Histograms of damage diameters on the front and back sides are presented in Fig. 2.

Analysis of the results presented in Fig. 2 shows that the diameters of damage on the front sides of the samples of both performances without a paint coating are approximately the same, and for the samples of both performances with a paint coating, the diameters of damage are larger, and for the samples of the I performance from a unidirectional carbon tape they are significantly larger. It can also be noted that the diameters of damage on the back sides of the samples of each performance are approximately the same and are significantly larger for the samples of the II performance from a unidirectional carbon tape compared to the samples of the I performance from a bidirectional carbon fabric.

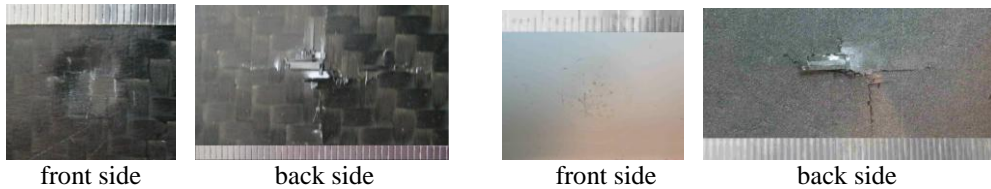
### I Performance

Fig. 3. View of impact damage to carbon plastic from the front and back sides.

After the impact tests and the completion of the damage parameters measurements, photos of the resulting damage of each sample were taken from both the front and back sides using a special magnifying webcam. Typical photos of damage to samples of two performances from the front and back sides are presented in Fig. 3.

Visual analysis of the photos of impact damage, which are presented in Fig. 3 and others, shows that damage at the same impact energy per unit thickness of the material

on samples with a paint coating on the front side is less visible, even despite the larger diameter of the damage.

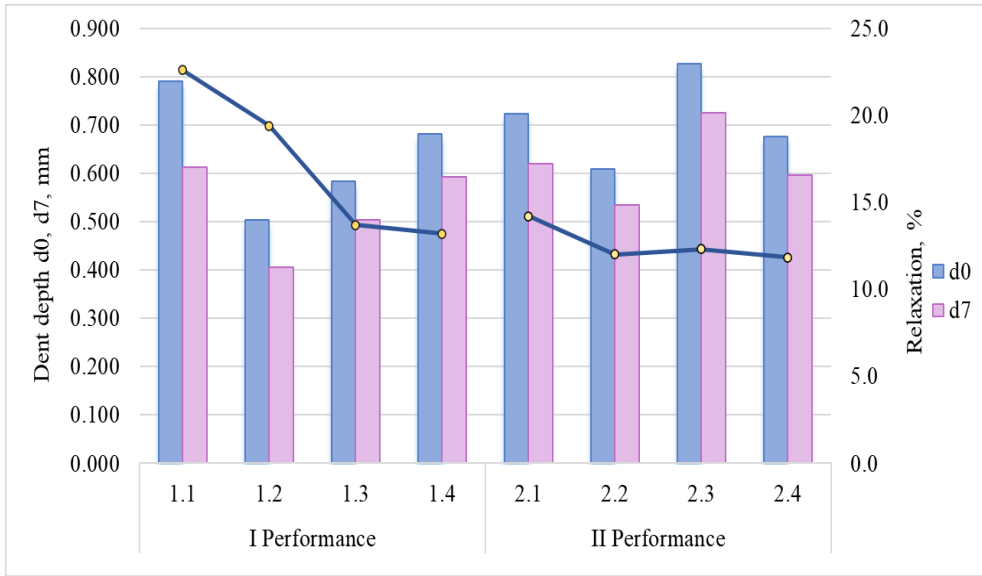
Fig. 4. Histograms of dent depth measurements immediately after impact  $d_0$  and 7 days post impact  $d_7$  with damage relaxation curves.

The generalized results of measurements of dent depths  $d_0$  after impact and 7 days after testing  $d_7$  are presented in the form of histograms in Fig. 4, and this figure also presents the results of damage relaxation calculations in the form of corresponding curves.

Analysis of the test results, which are presented in the form of histograms and curves in Fig. 4, allows us to conclude that during the week in all samples there was a decrease in the depth of the dents compared to the initial  $d_0$ . That is, as expected, the so-called relaxation of damage occurred, and in carbon fiber based on bidirectional fabric it was more likely due to the cross-woven fabric structure of the reinforcing component compared to carbon fiber based on unidirectional tape.
